Blast of Kakhovka dam in Ukraine

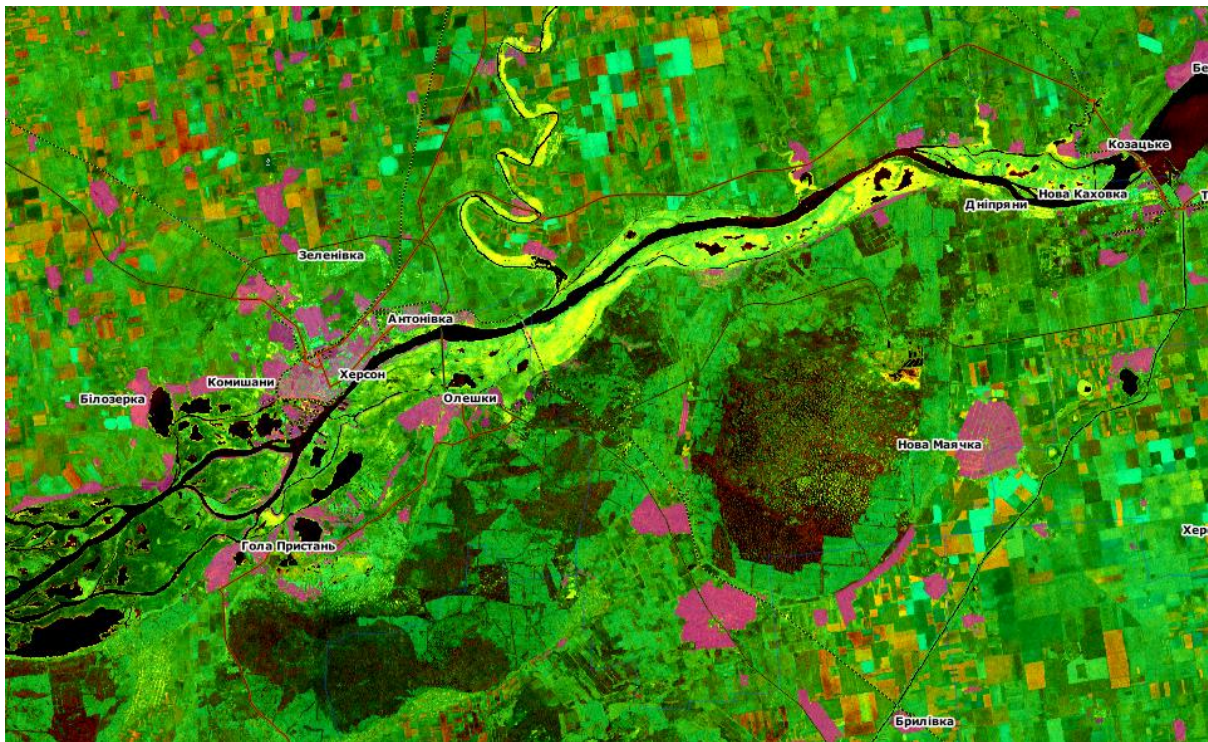
The map below shows a pseudo-true Color Composite derived from a single date Sentinel-1 SAR image from June 1, 2023 five days before the catastrophe came to happen. Dark areas are flooded.
