Flood monitoring with Sentinel-1 radar data in northern Germany

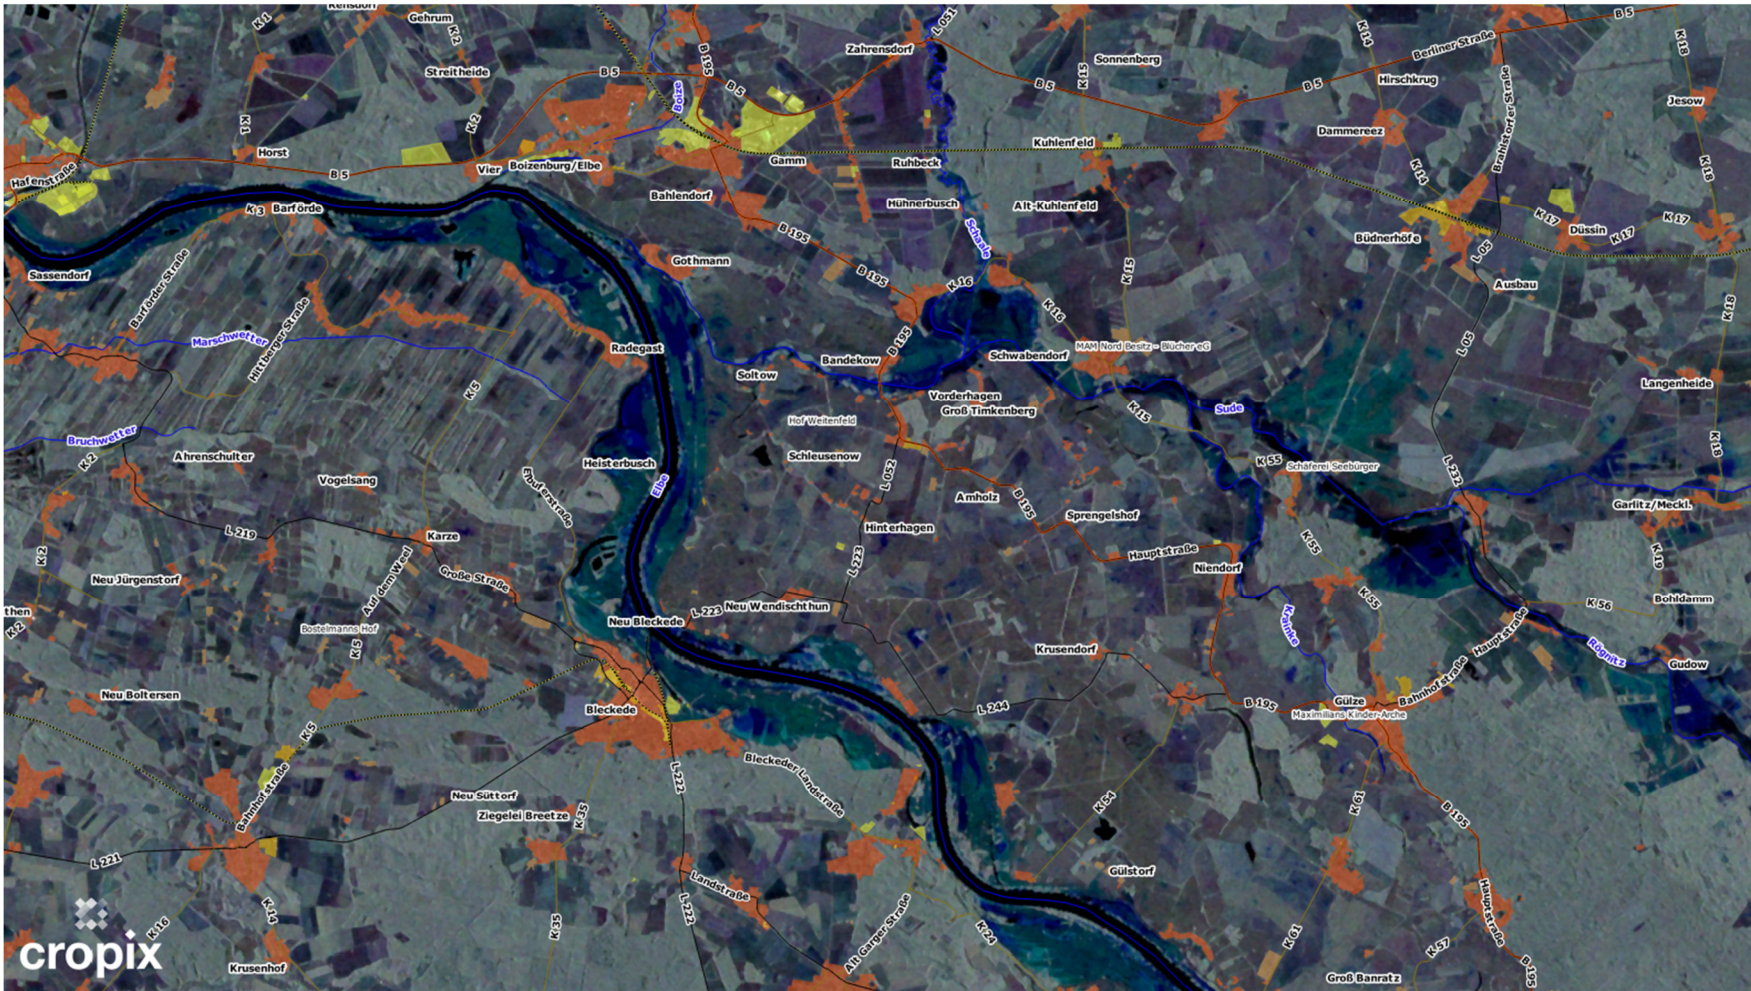
Finally, a shot east of Lauenburg on the Elbe. Here too, the course of the flood is clearly visible in color.
